INDOOR AIR QUALITY ASSESSMENT

**Springfield State Office Building
436 Dwight Street
Springfield, Massachusetts**

Prepared by:
Massachusetts Department of Public Health
Bureau of Environmental Health Assessment
January, 2002

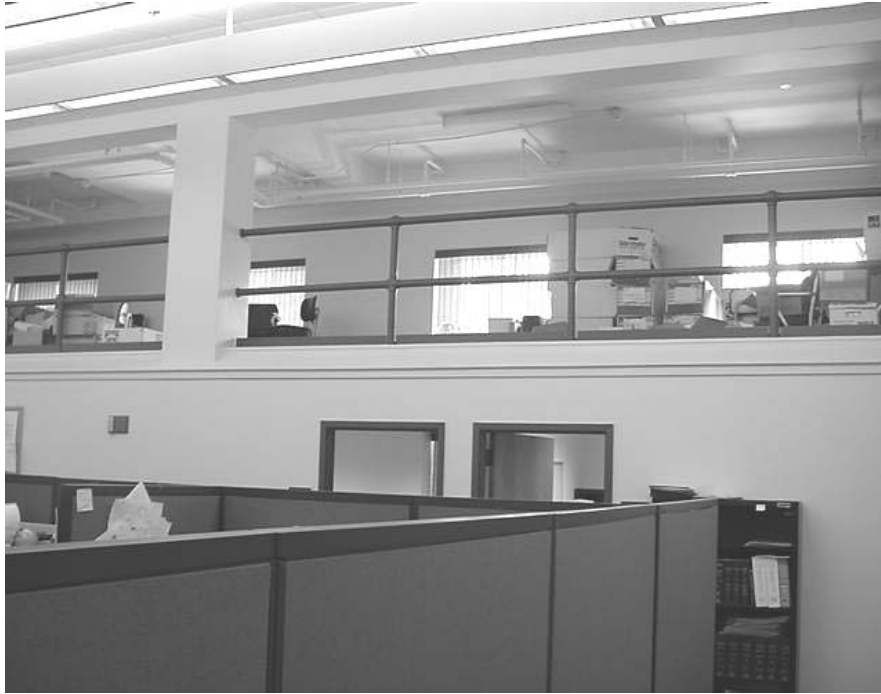
Picture 2

Of note is the administrative and judge's lobby area of the Division of Industrial Accidents (DIA) office. This area was reconfigured from its original use, which appears to have been the loading dock/freight area for the former post office. A large, concrete/steel balcony exists along the exterior wall of this area (see Picture 2). The area

Large, Concrete/Steel Balcony Located Along the Exterior Wall of the DIA Office

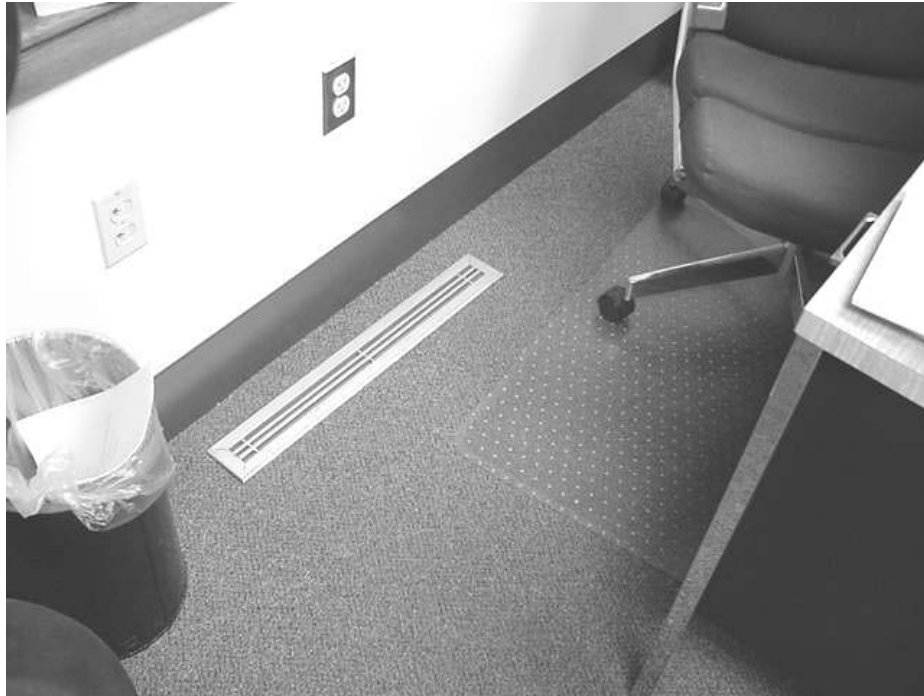
Picture 3

beneath the balcony was subdivided and now serves as the DIA judge's chambers. Each of these offices has a fresh air diffuser at floor level (see Picture 3). The system provides fresh air for adequate temperature control in the DIA judge's chambers. No exhaust vents exist in the chambers. Grates in the suspended ceiling of the main administration area appear to be part of the ceiling plenum system. The ceiling plenum exhaust system is designed to draw air from an undercut below the judge's chamber door into the administrative area. Air then exits through the ceiling-mounted grates into the ceiling plenum. Corrugated decking partially obstructs the ceiling plenum grate (see Picture 4). This blockage can degrade the ability of the plenum system to remove normally occurring environmental pollutants, particularly from the judge's chambers when the hallway doors are closed.

Fresh Air Diffuser at Floor Level

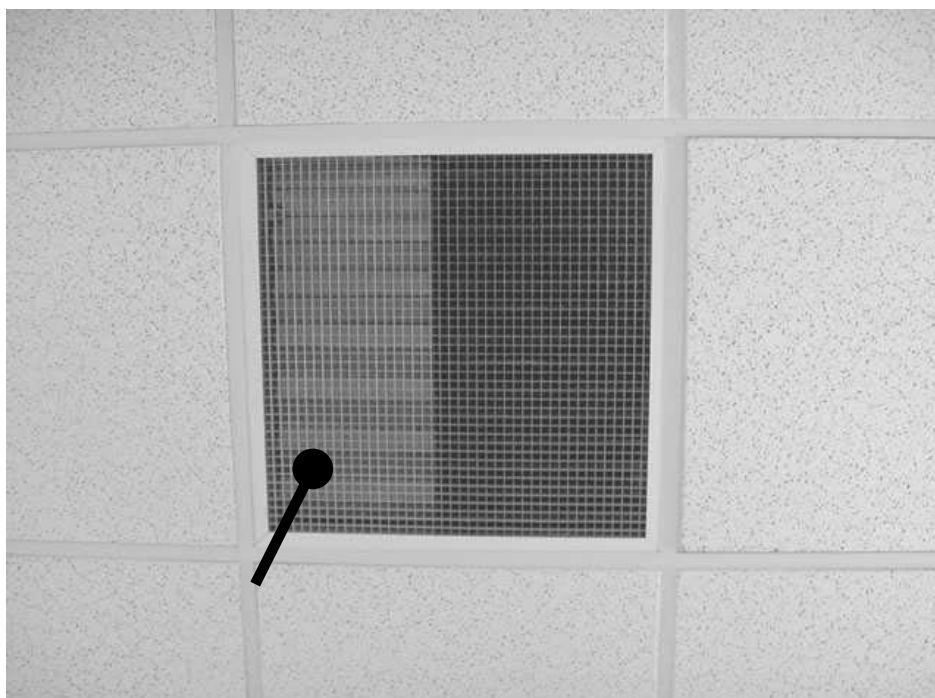
Picture 4

Partially Obstructing the Ceiling Plenum Grate Is Corrugated Decking

8. Examine the feasibility to increase the draw of air into the return vents of the ceiling plenum to increase removal of air from the DIA area.
9. Ventilation industrial standards recommend that mechanical ventilation systems be balanced every five years (SMACNA, 1994). Consult a ventilation engineer concerning re-balancing of the ventilation systems.

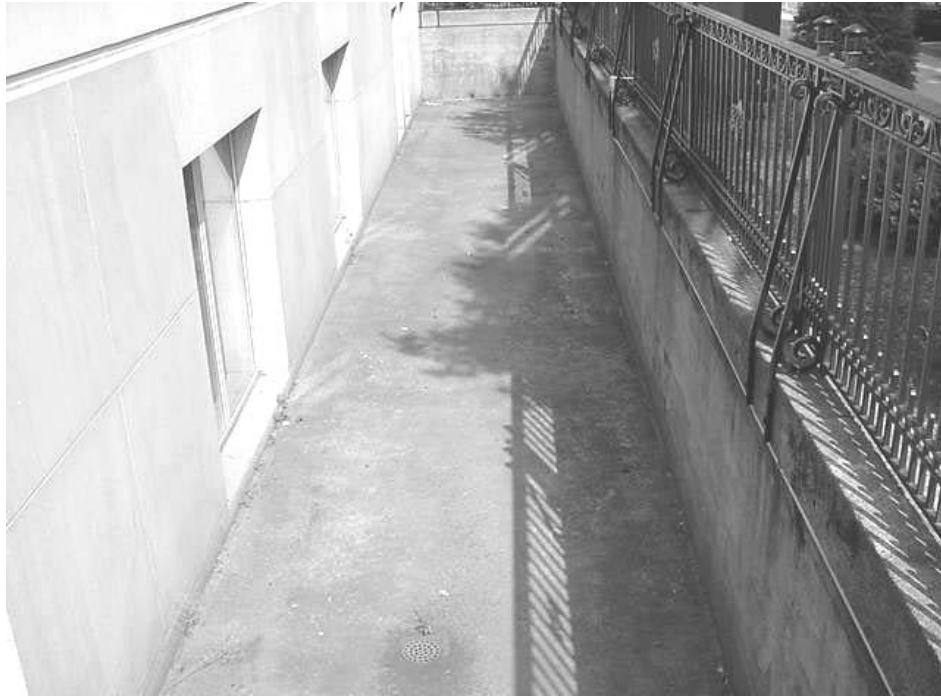
Picture 5

The configuration of the building can make the lower level of the building vulnerable to flooding during flash flooding conditions. The building is surrounded by cement lined pits with drains (see Pictures 5 and 6). If the rate of water entering the cement-lined pit exceeds the drainage rate of the drains, the water level can rise and come into contact with window frames or the exterior door leading to the mechanical room. Of note is the design of the drainage system. According to staff, the roof drains for the building are connected to the sewer drain system, which has two pipes that exit the

Building Is Surrounded By Cement Lined Pits with Drains

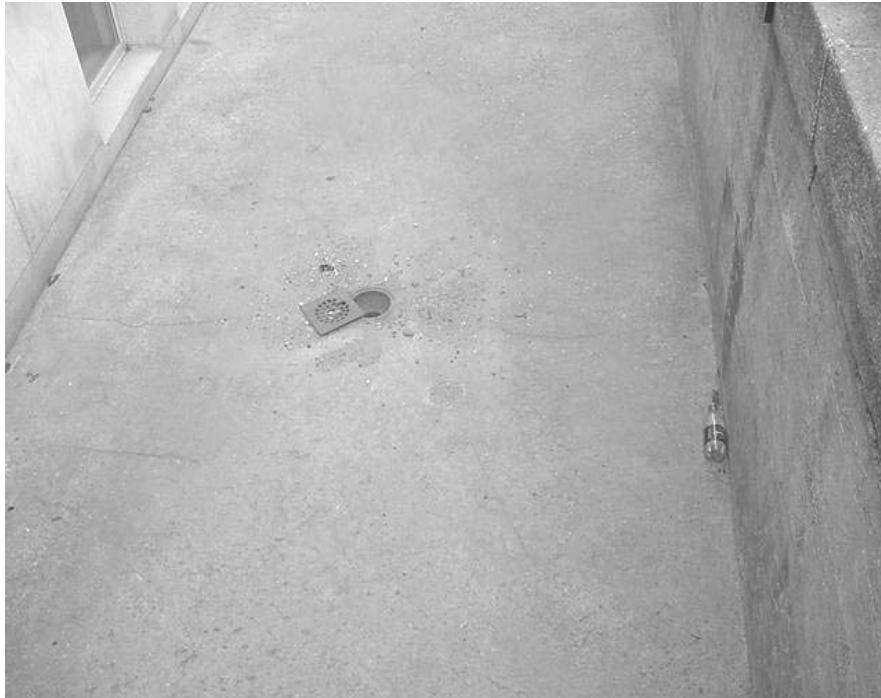
Picture 6

Drain in Cement Lined Pit

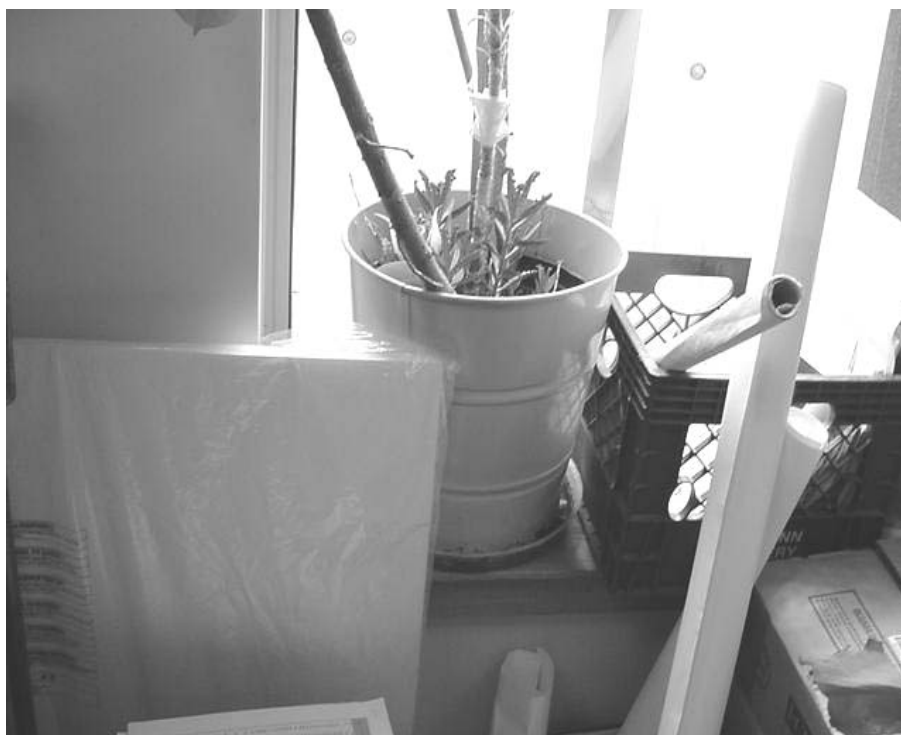
Picture 7

Other potential contributions to excess moisture/mold concerns were also identified during the assessment. Plants located throughout the building, particularly on the 5th floor, can contribute to mold and/or spores. Plant soil, standing water and drip pans can serve as mediums for mold growth (see Pictures 7 and 8). Drip pans should be inspected periodically for mold growth. Over watering of plants should be avoided. Many plants are located on, above and around fan coil units. Dust, mold spores and pollen can be drawn into fan coils and distributed throughout a room.

Plant On Window Sill

1. Complete corrective actions recommended in letter concerning flooding as soon as possible (see Appendix A).
2. Examine plants for mold growth in water catch basins. Disinfect water catch basins if necessary. Consider reducing the number of plants in certain areas. Remove plants from the proximity of fan coil units to prevent the aerosolization of mold, particulates and pollen.
3. Consider placing plastic/rubber mats beneath water coolers.

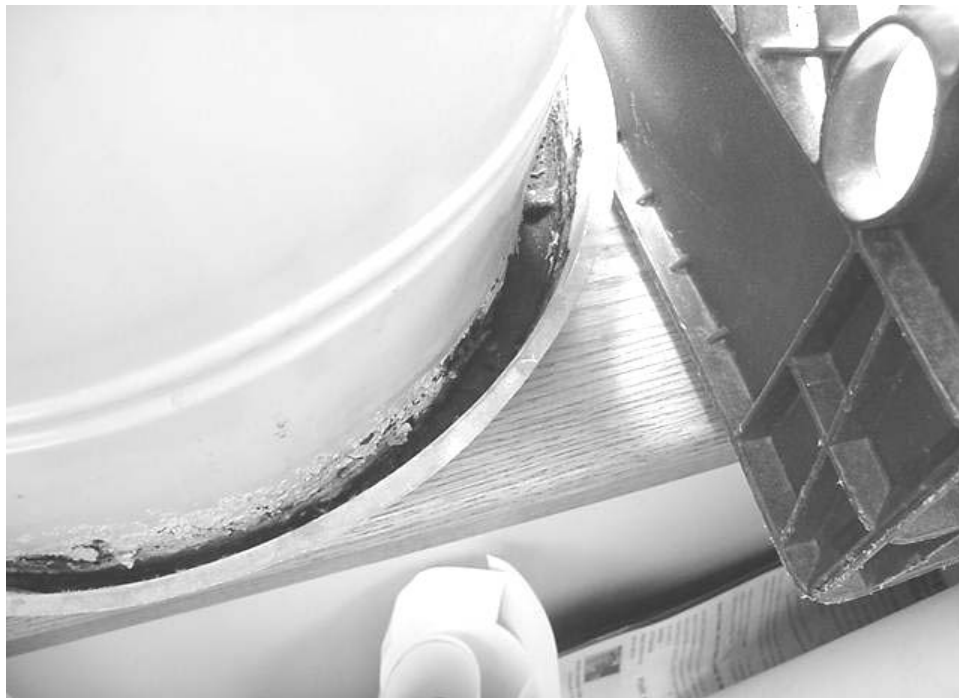
Picture 8

Build Up Of Sludge in Drip Pan

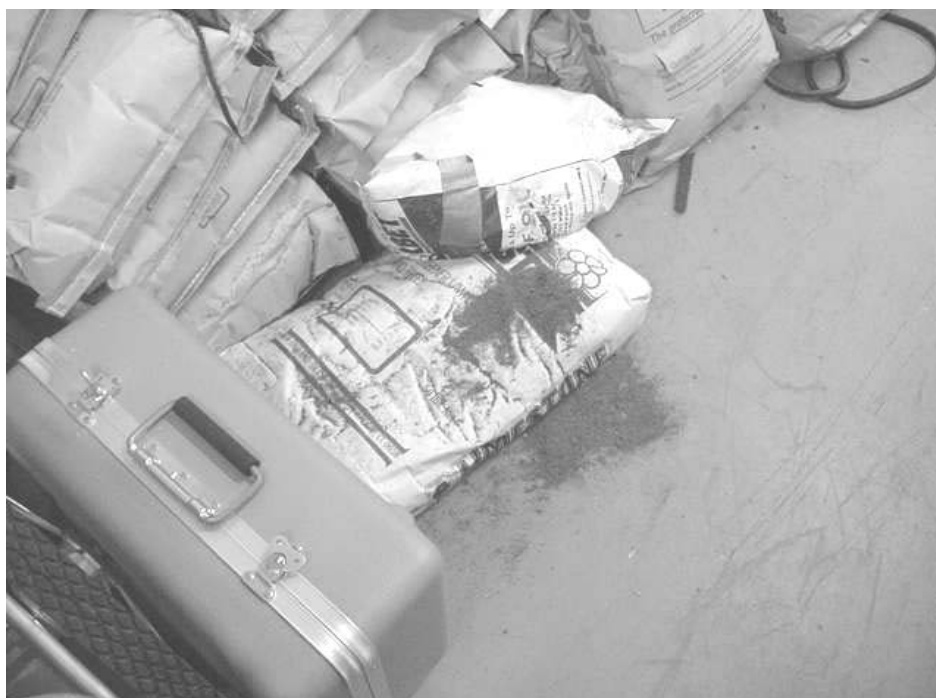
Picture 9

A number of containers containing hazardous materials were discovered in a basement-level agency storeroom (see Pictures 9-11). Containers such as gasoline cans should be stored in a flameproof cabinet that meets the specifications of the National Fire Protection Association (NFPA) (NFPA, 1996).

Spilled Materials in an Agency Storeroom in the Basement

7. Remove equipment in the basement and store it in an area with adequate mechanical exhaust ventilation to remove off gassing materials from the interior of the building. Flammable materials should be stored in a flameproof cabinet that meets the specifications of the NFPA (NFPA, 1996).

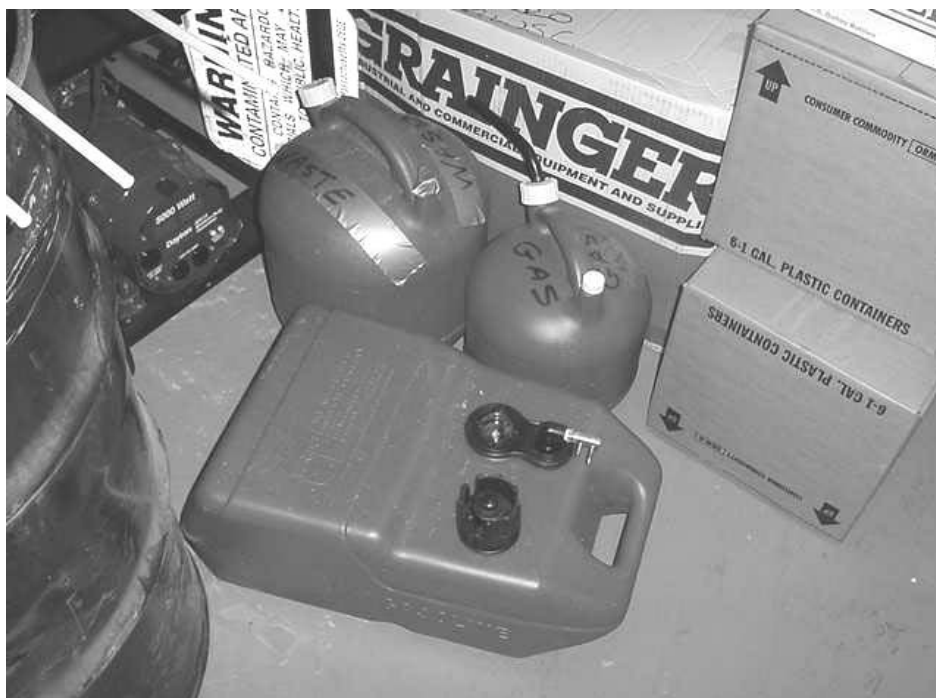
Picture 10

Gasoline Containers in an Agency Storeroom in the Basement

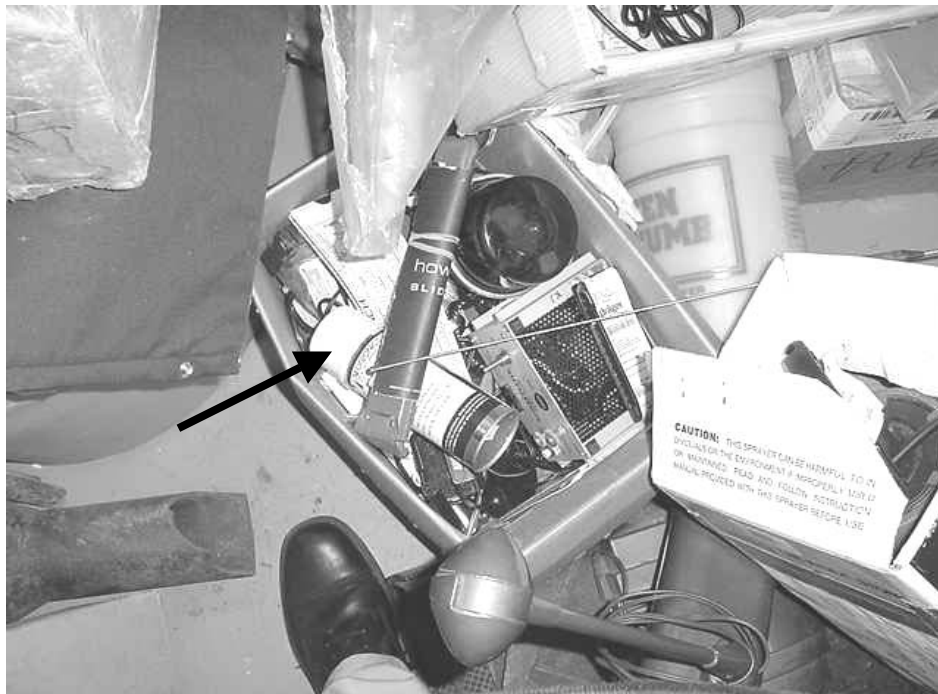
Picture 11

Spray Can in an Agency Storeroom in the Basement
